# Surelock Homes

*This report exclusively prepare for: Sample*

**Your new home**

8/23/2018

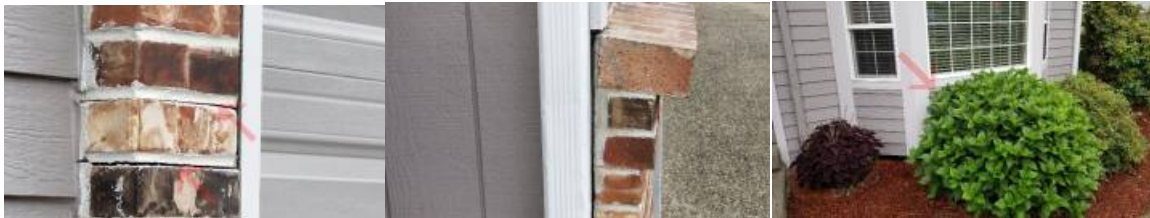
Shrubbery too close to siding Conducive condition for wood decay. Moisture wicks into the wood siding/ and or shorten the life of the painted surface.

Damaged/ decay from moisture. Typical of LP type siding.

Observed wood decay at wood siding. Wood destroying organism (WDO) or conditions that may cause wood decay (conducive conditions) are noted. WDOs include wood decay, moisture ants, carpenter ants, Lyctid and Powder Post Beetles. LOCATED AT ARROW AS NOTED IN PHOTO.

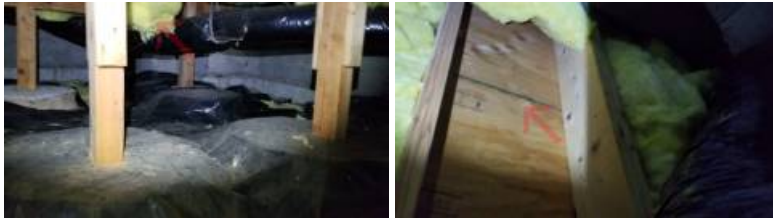
Insulation is not well attached and or some is missing at the underside of the floor and its effectiveness is in question. TYPICAL.

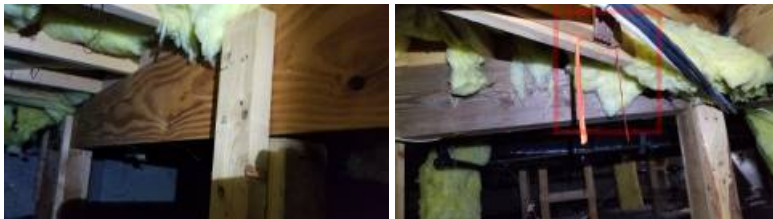
Over spanning is noted, A foundation contractor should install additional supports as needed.

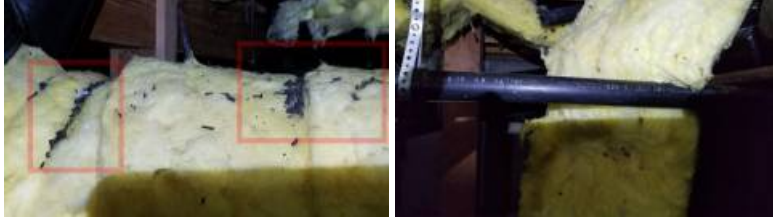
Rodent activity is noted. Extensive rodent tracks are noted throughout much of crawl space area. UNHEALTHY CONDITIONS EXIST. Removal of feces , contaminated vapor barrier and insulation required. REPLACEMENT WITH 10 mil black vapor barrier and like insulation R value.

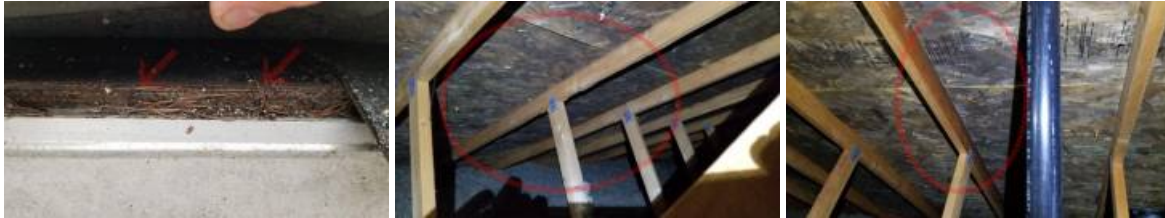
Sheathing lack proper metal flashing / D-metal. Result in decay of sheathing. Repairs and or replacement needed .

Fungal growth is noted due to lack of ventilation and blocked attic vents.

Concrobium Fungicide Stain Eraser is a powerful cleaning solution that targets tough and embedded mold and mildew stains on outdoor and indoor surfaces. Perfect for black mold stains. BECAUSE TREATMENT DOES NOT CHANGED COLOR OF INFECTED AREA, IT IS SUGGESTED THE LABEL FROM THE BOTTLE IS SECURED TO THE TRUSS AT THE ATTIC ACCESS AREA WITH DATE OF TREATMENT WRITTEN ON LABEL

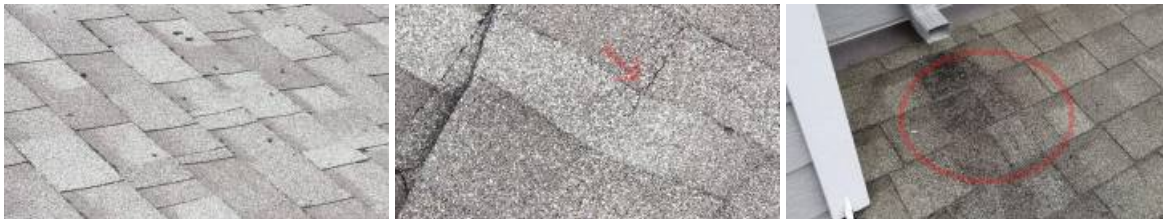
Stress cracking noted at ridge Cap noted. Location 2nd level North dormer. Recommend sealing with approved roofing sealant.

Gradual loss noted at downspout . Recommend extending down spout closer to a roof surface to avoid impact of drainage.

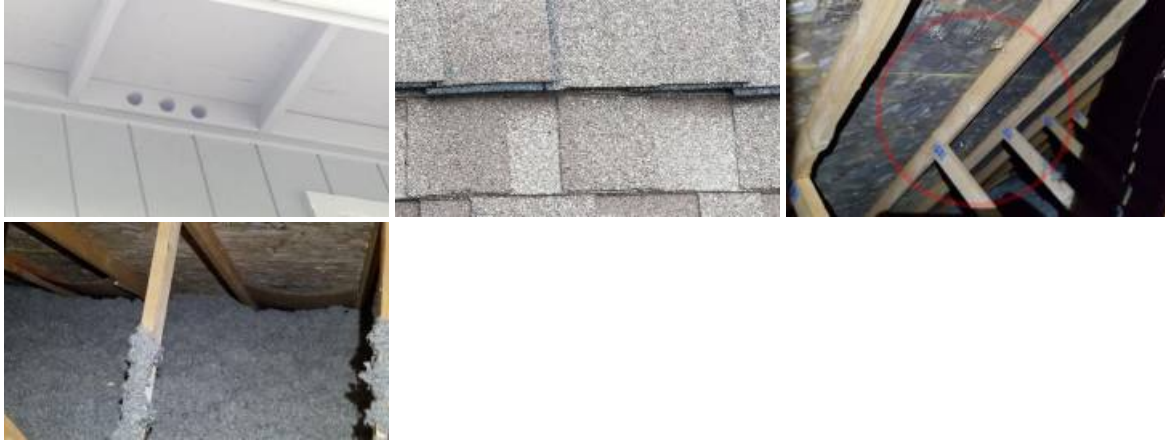
Baffles are NOTED at soffit vents. Installing baffles add to the life cycle of the shingles and help keep the attic cooler.

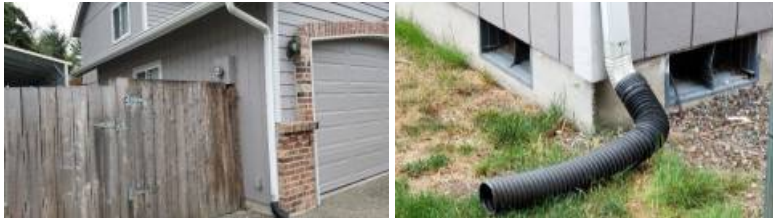
Full gutter system is noted. Diverter missing, replacement needed. Aim diverter away from structure to avoid moisture drainage into the crawl space area.

Missing splash blocks are missing from all downspouts. Install them so they slope away from structure.

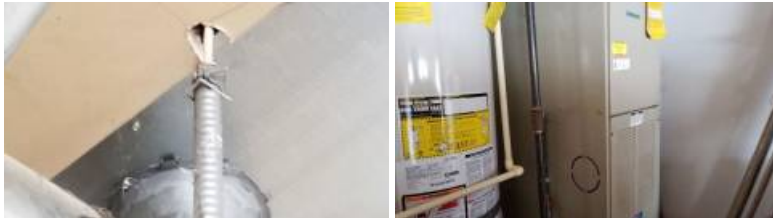
Unsafe wiring, correction needed.

HVAC UNIT LACKS INDUSTRY STANDARD EMERGENCY SHUT OFF.

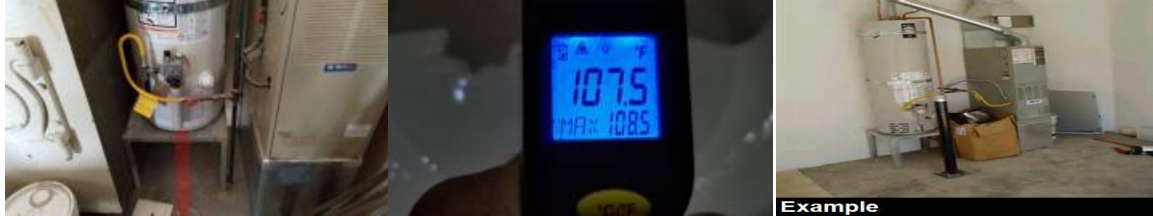
**BARRIER OR ELEVATION REQ'D IN GARAGE OR CARPORT. ADD PROTECTIVE BOLLARD TO PROTECT WATER HEATER FROM BEING HIT BY VEHICLE. CORRECTION NEEDED, Current industry standard recommend a sediment leg be installed at water and HVAC unites. A sediment leg also know as a drip leg prevent sediment in the natural gas to enter into the gas fire appliance a block the proper operation of the appliance.**

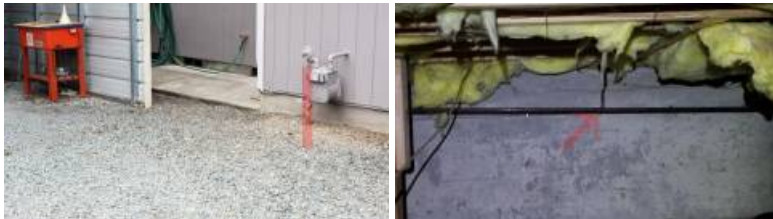
Natural gas meter is at: North side of the home. UNSAFE CONDITION EXIST. Bollard lacking in area. Gas line lacks proper attachment per industry standards.

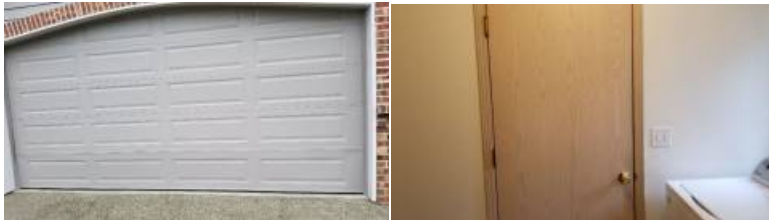
Self closing hinge was industry standards . " self closing device req'd on door from attached garages"( IRC2009/2012 302.5.1).

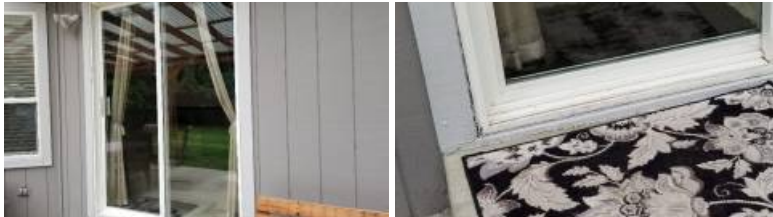
Sliding glass, **Screen door missing for slider.**

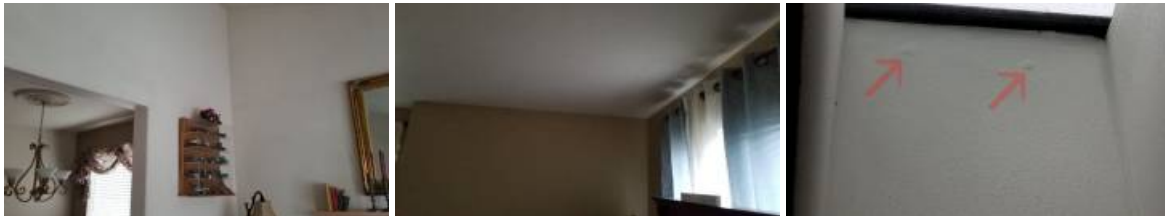
Nail pops are a result of wet or green lumber being utilized during the construction process. Repairs are simple. Use a nail punch and hammer to set the nail head. Caulk and paint the small indentation.

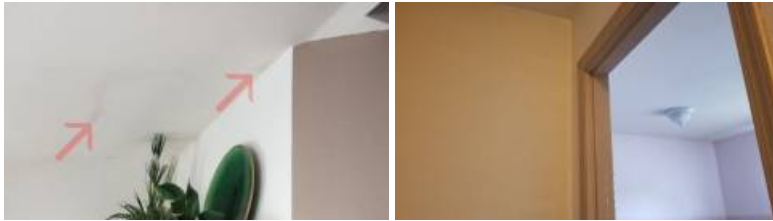
**MAIN LEVEL :** Drywall, Ghosting of ceiling sheet rock. Ghosting is the buildup of ghost marks can be caused by any combination of moisture, cold spots, static electricity, air current, and a supply of dust, soot, and other particulate that can drift with the air.

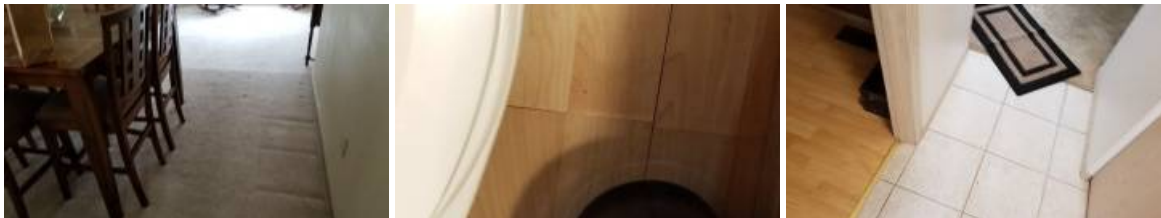
**NOTABLE** Squeaking in subfloor noted. Squeaking appears to be result of loose subfloor. Correction is re-nailing sub floor area, recommend using screws.

Carpet, Wood, Asbestos / the age and the style for the vinyl and or linoleum flooring is indicative for asbestos. Asbestos was no longer allowed to be sold in 1980 to present.
