# Surelock Homes

*This report exclusively prepare for: Sample*

**Your new home**

8/23/2018

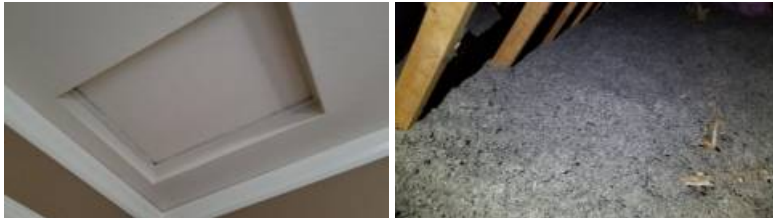
TYPE: Mineral wool.

Observed 12 inches of blown in attic with an R value of 30 this is above average.

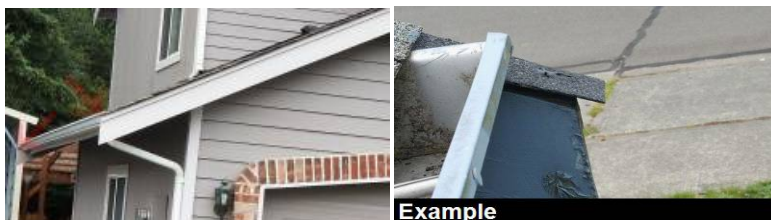
The covering should extend 1 inch beyond the fascia tail to protect the bottom portion of the fascia trim.

SAMPLE of proper fascia tail protection.

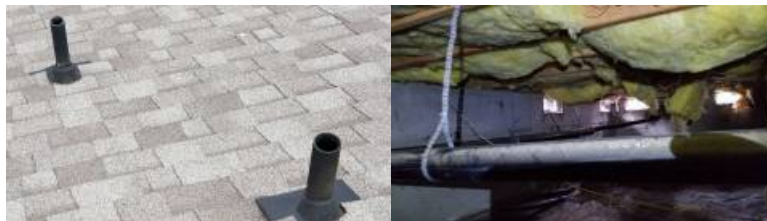
Plumbing vents appear serviceable.

Visible components of the water drainage system and plumbing vent pipes functioned as intended at the time of the inspection. Also see kitchen and bathroom pages regarding plumbing conditions.

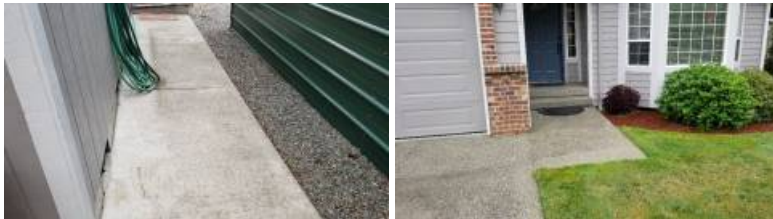
Concrete, Service walk only, type is concrete.  
Concrete.

Excess of settlement of concrete service walk is noted. Recommend installing rain gutters on carport area to avoid possible settlement.

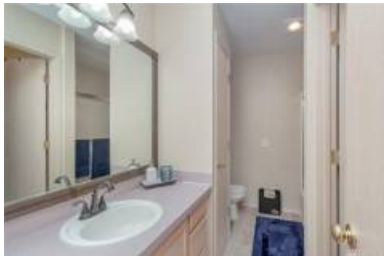
Master Bedroom, Upstairs.

Stopper missing or does not work.
